Inspection Report

Property Address:
333 Wild Raspberry Lane
Stone Ridge NY

Hudson Valley Property Inspections

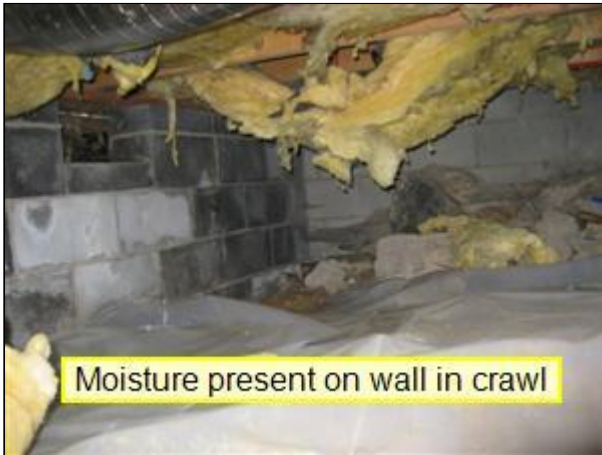
1.0 Picture 5 crawspace under kitchen

🔍 (3) Visible signs of water intrusion in the crawspace (along front of home) are present from dampness along the block wall. I am unable to determine the extent of intrusion or how often it occurs. Cross ventilation may help as the crawls has no ventilation. I recommend further investigation or correction by a qualified licensed contractor or water infiltration specialist. Refer to the diagram as a guide if a drainage system is needed.

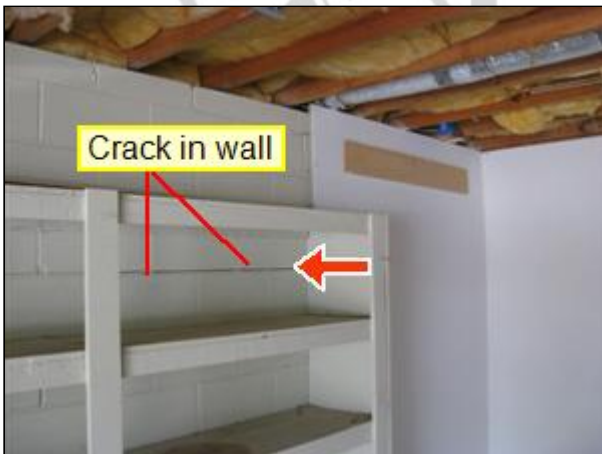
1.1 Picture 1

🔍 There is a horizontal crack(s) in the foundation wall at the left side (facing front). These cracks do not appear significant to require repairs at this time. This is my opinion and you should seek a second opinion by a qualified person.

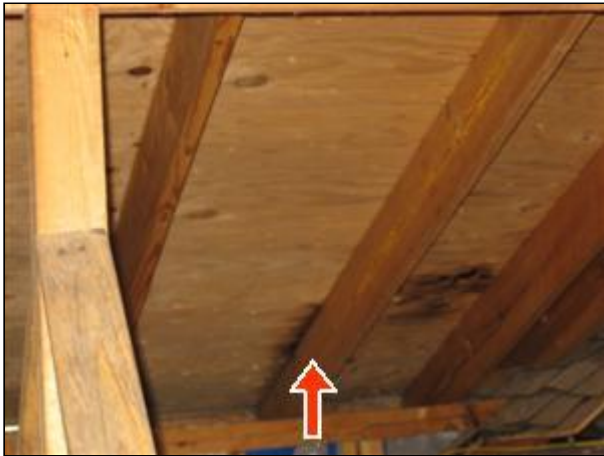
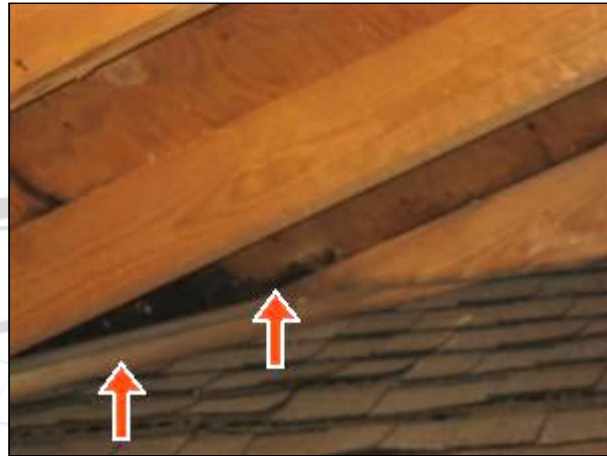
1.5 Picture 1

🔍 Leak signs in attic perhaps or likely from the *old roof* as this newer roof appears in tact. I am unable to determine if leak exists due to no recent rain.

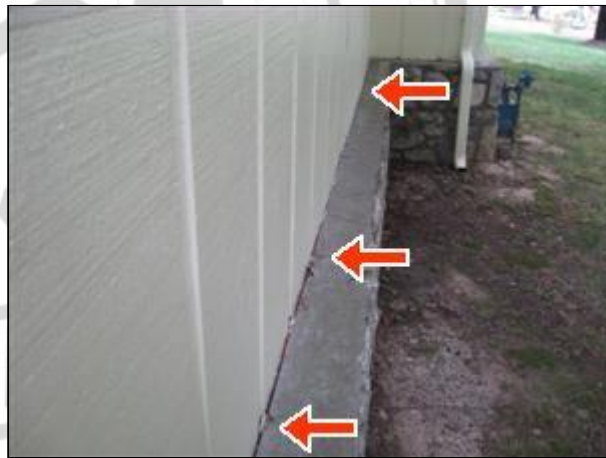
2.0 Picture 1

Periodical maintenance caulking needed and recommended to keep water from weeping under siding at concrete shelf. FYI

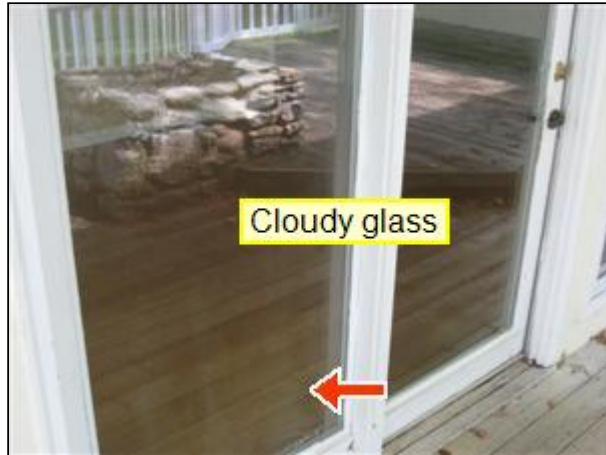
2.1 Picture 1

🔧 Patio doors at rear of home are cloudy or seal is broken. Glass panes that have lost their seal (cloudy) can usually be replaced without replacing the entire unit. A qualified contractor should inspect and repair as needed.

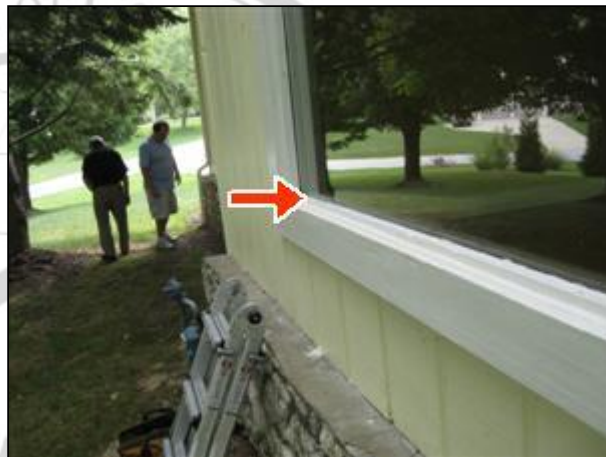
2.2 Picture 1

🔧 The trim stop for fixed pane is weathered and indicates that water may be getting below trim. I recommend a paintable sealant be applied and paint trim.

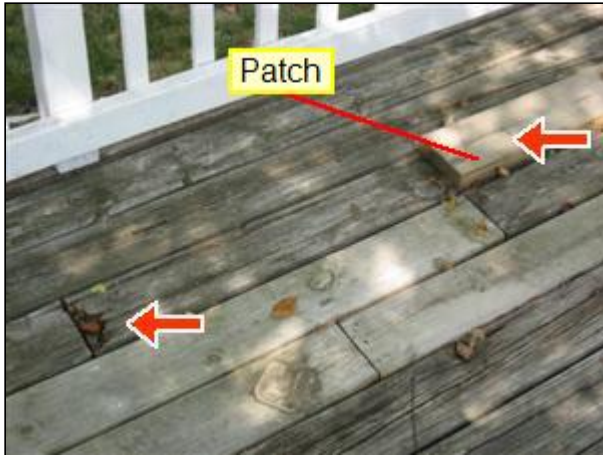
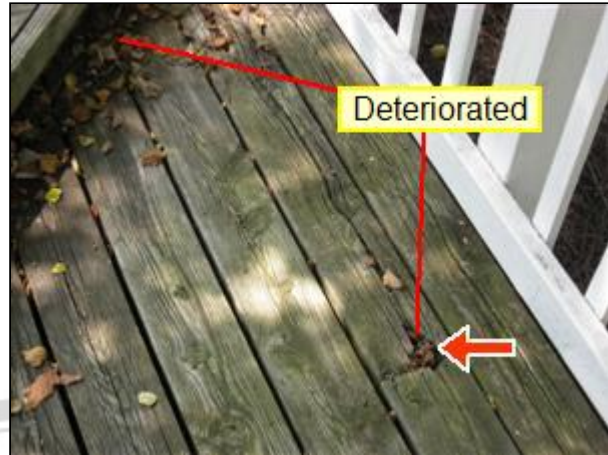
2.3 Picture 2

🔨 (2) The 2x6 decking on the deck at the rear of home has several boards that are deteriorated. A general replacement is likely. A qualified contractor should determine whether a repair or replacement is needed.

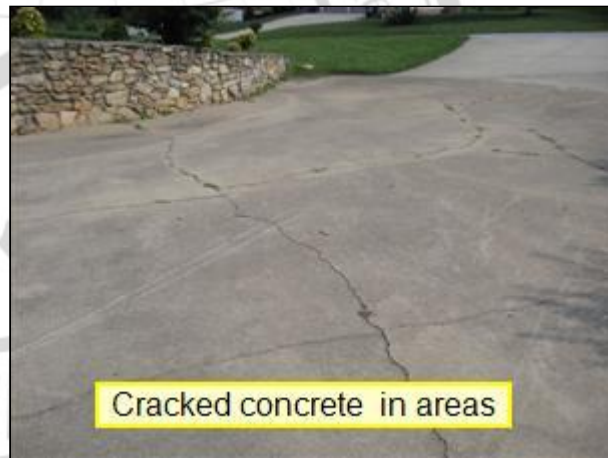
2.4 Picture 1

🔨 The concrete drive at the front of home is pitted in areas and has settlement cracks. Further deterioration can occur if not repaired. A qualified contractor should inspect and repair as needed.

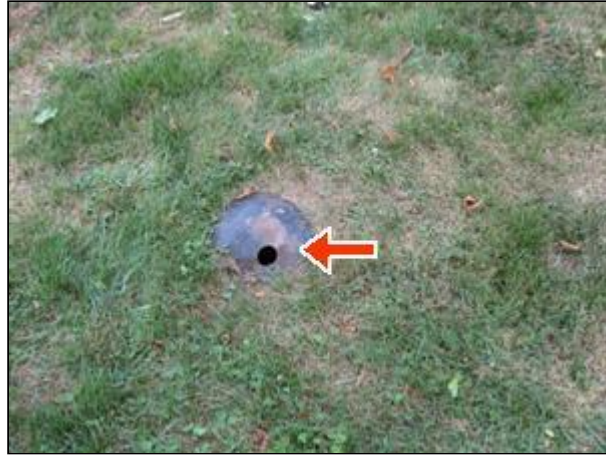
2.6 Picture 1

🔍 (1) Old propane tank in ground and is discontinued. I did not determine if gas remains in discontinued tank? I recommend further investigation by a qualified person.

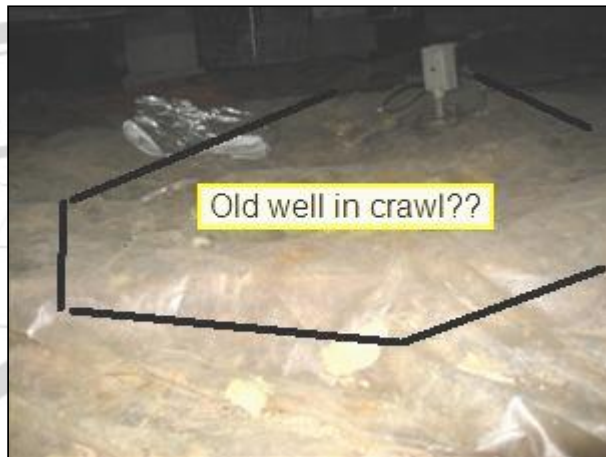
2.6 Picture 2 in crawlspace under new addition

🔍 (2) There is an odd configuration in ground under addition in crawlspace. This may be an old well? I am unable to determine. I recommend a qualified well drilling company or plumber investigate further to determine if any further action is needed to correct.

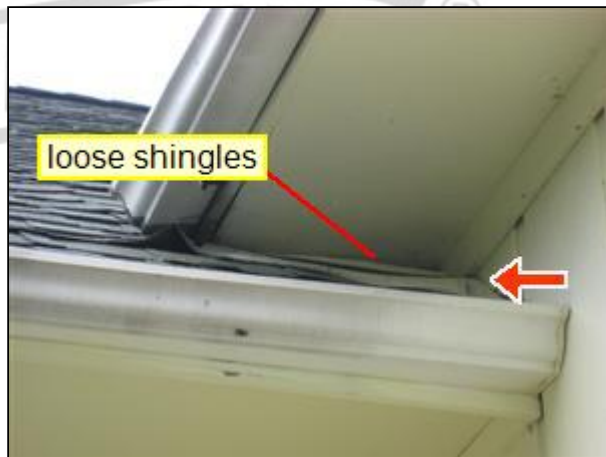
3.0 Picture 3

(2) Shingles loose under eave at front of home, needs adhesive.

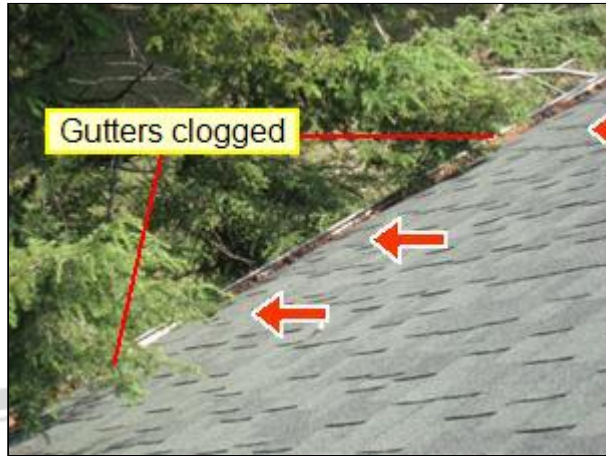
3.3 Picture 1

🔧 The gutter needs cleaning of debris at the virtually all areas where gutters are installed. Gutters that drain poorly or clogged can lead to many costly problems such as deterioration of fascia, soffit or roof edge. It can also cause gutters to pull loose and lead to possible water intrusion. A qualified person should repair or replace as needed.

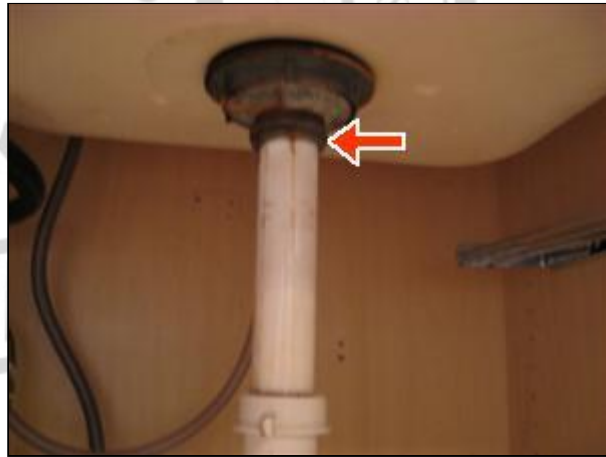
4.0 Picture 1 Right sink basin

🔧 (1) The basket strainer had leaked and corrected itself for the time being at the Kitchen sink. Repairs are needed. A qualified person should repair as necessary.

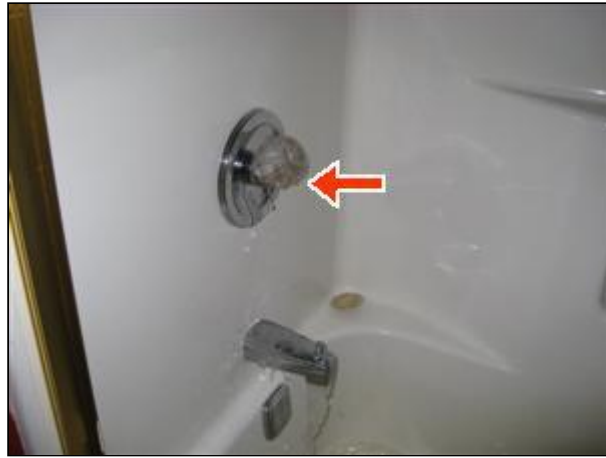
4.1 Picture 1 hall bath

🔧 (1) The control knob leaks at the hall bath. Repairs are needed. A qualified licensed plumber should repair or correct as needed.

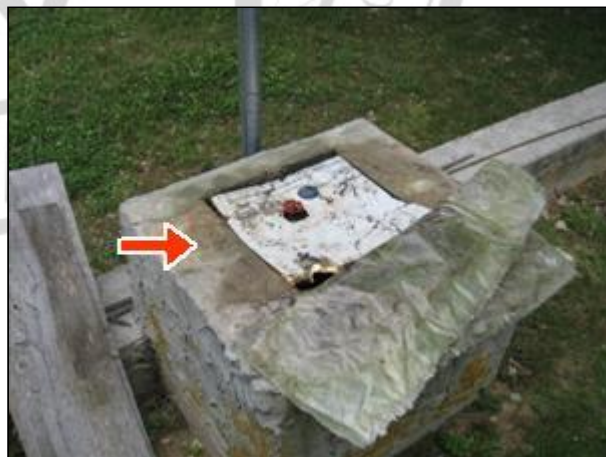
4.1 Picture 3 Well head

🔧 (3) I recommend the well head lid be insulated better before winter. FYI

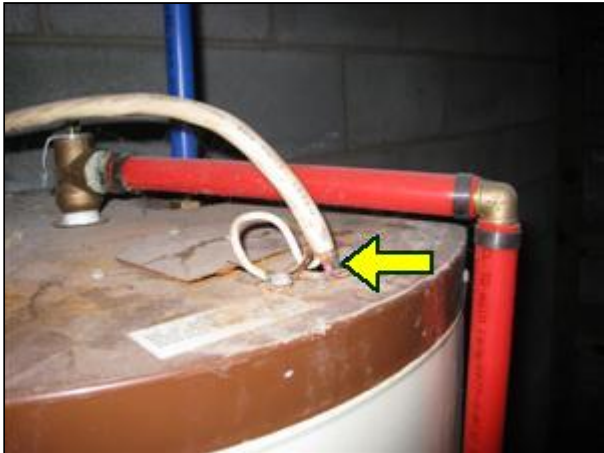
4.2 Picture 1

🔧 The wiring for the water heater missing romex connector. Electrical issues are considered a hazard until repaired. I recommend a licensed electrician correct as necessary.

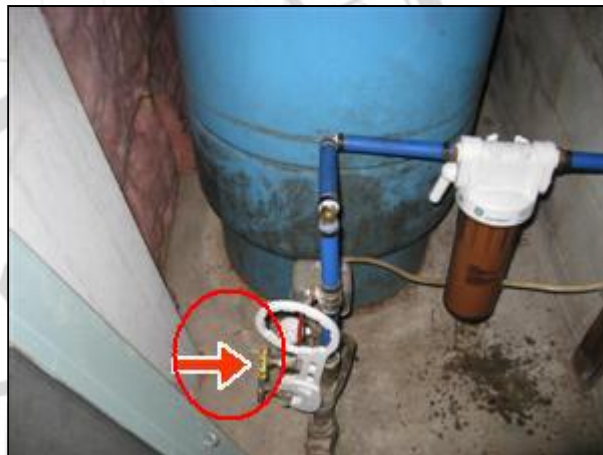
4.3 Picture 1 In basement

The main shut off is the yellow knob located in the basement at the pressure tank. This is for your information.

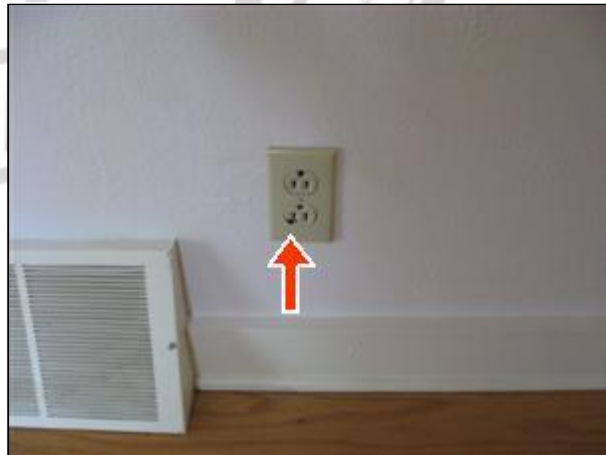
5.3 Picture 1

🔧 (1) The wall switch is broken (unsafe) at the upstairs closet for air handler. At least two outlets are broken at LR and entry way. Electrical issues are considered a hazard until repaired. A qualified licensed electrician should perform repairs that involve wiring.

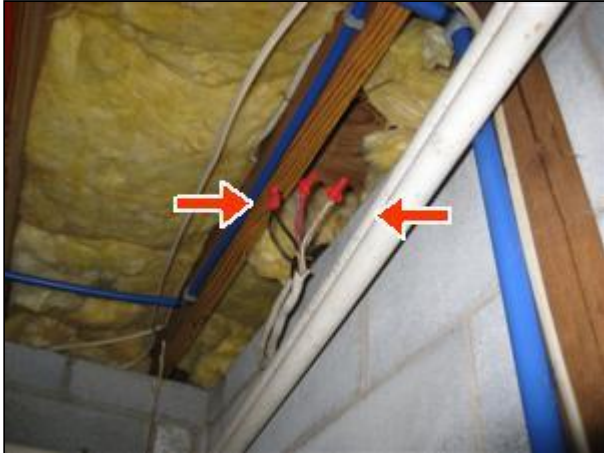
5.3 Picture 2

🔧 (2) Several loose wire ends needs placing inside a box with a cover-plate in the basement at the pressure tank of well. I recommend repair as needed.

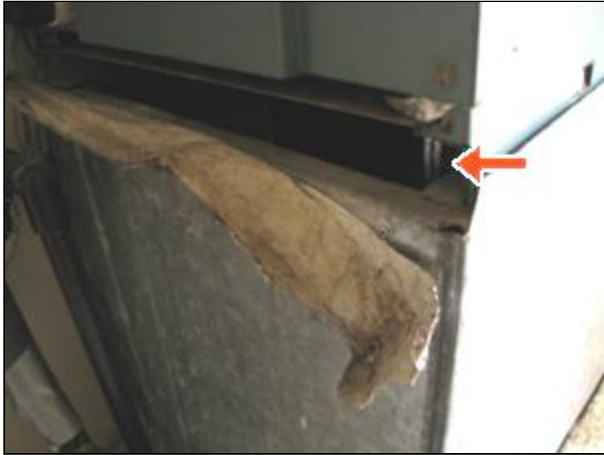
6.3 Picture 1

🔧 (1) The washable filter is collapsed and needs replacing at upstairs. The filter needs replacing with a rigid frame to prevent filter from falling out of alignment. (Picture 1) The filter in basement (Picture 2) needs replacement and in crawlspace which is difficult to access due to the crawlspace (Picture 3). A qualified person should repair or replace as needed

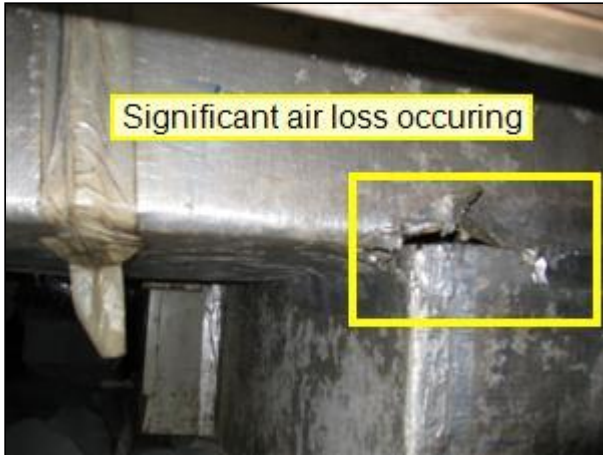
6.3 Picture 4 crawlspace new addition

🔧 (2) The supply duct pipe or main plenum is failing in the crawlspace. Energy loss is occurring in crawlspace and immediate correction is needed. A licensed HVAC contractor should service or repair unit.

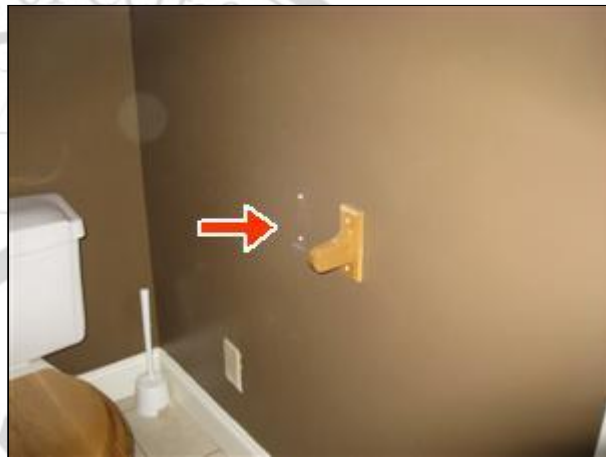
8.1 Picture 1

🔧 The tissue holder on the wall is damaged at the master bath. I recommend repair as necessary.

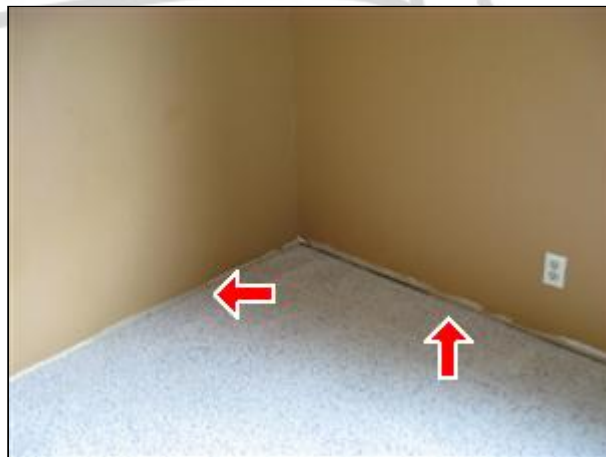
8.2 Picture 1

🔧 (1) The Baseboard is missing at the upstairs (right of hall bath). Repairs are needed. A qualified contractor should inspect and repair as needed.

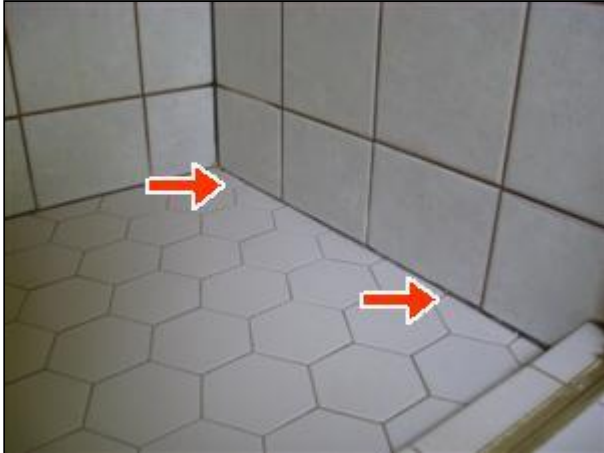
8.2 Picture 2 Upstairs bath

🔧 (2) Tile at shower pan and wall surround are loose and missing mortar or grout and sealer at the upstairs bath. Repairs are needed to prevent water damage to shower/bath. A qualified person should repair or replace as needed.

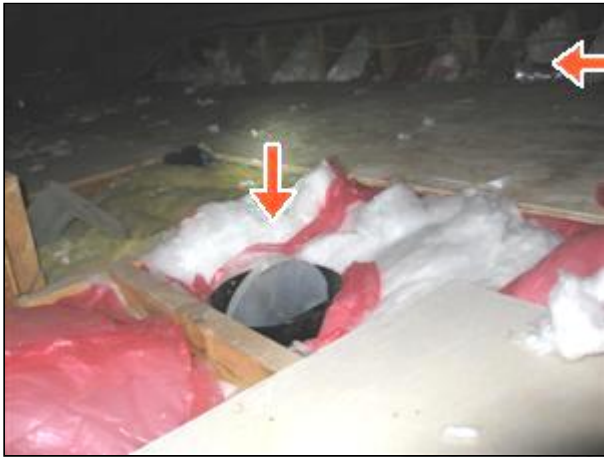
9.4 Picture 1

🔧 The Exhaust fan does not vent to outside at the hall bath and master bath. Vent pipes should terminate outside and not in the attic. Many homes have their vent pipe poised at the roof vent such as yours. It is up to you to determine whether or not this is a concern or needs further consideration from a general contractor. A qualified contractor should inspect and repair as needed.
